NASA Contractor Report 4617

# Results of the Examination of LDEF Polyurethane Thermal Control Coatings

*Johnny L. Golden*  
*Boeing Defense & Space Group • Seattle, Washington*

July 1994

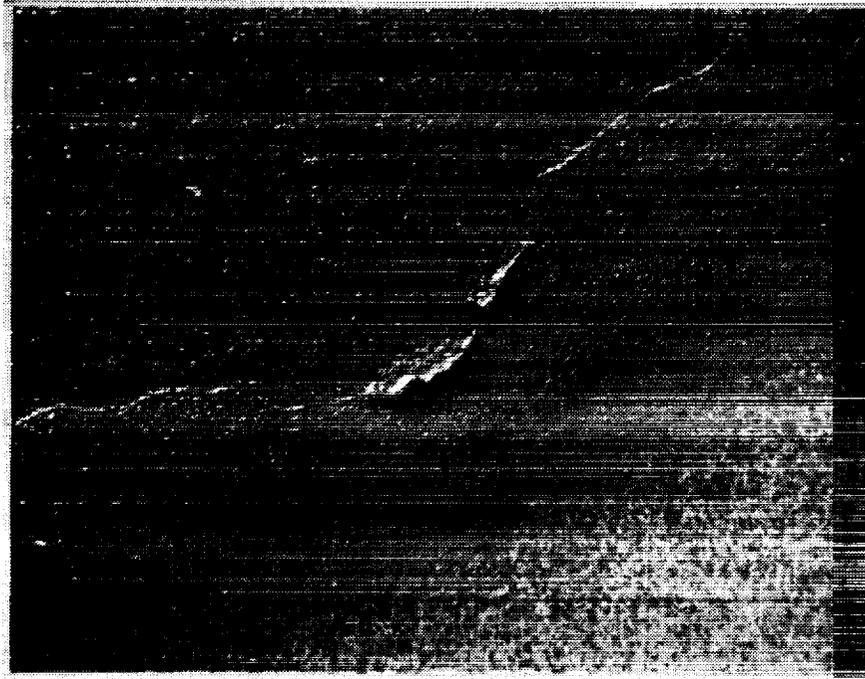
Low magnification (16X) microscopy was used to observe contaminants and the general integrity of tray clamp paint disk specimens. Contamination from numerous sources was observed on all specimens. Fibers and shop debris were seen imbedded in uneroded paint coatings (see figures 12 and 13). Yellow particles were observed on and around the black paint on one specimen, apparently the result of paint overspray from when the tray clamp disks were originally painted (see figure 14). The yellow particles, from an unidentified paint, were determined to be preflight contamination because of the smearing of these particles under fastener hardware applied at the time of spacecraft integration, also visible in figure 14. Uneroded white paint disks exhibited solvent marks, where it appears that a solvent wiping operation wicked contaminants into the coating surfaces, resulting in a mottled discoloration pattern after environmental exposure (see figures 13 and 15).

Figure 12. Chemglaze Z306 black polyurethane paint on tray clamp position A6-2, viewed at 16X magnification. Contaminant fiber imbedded in the paint film.

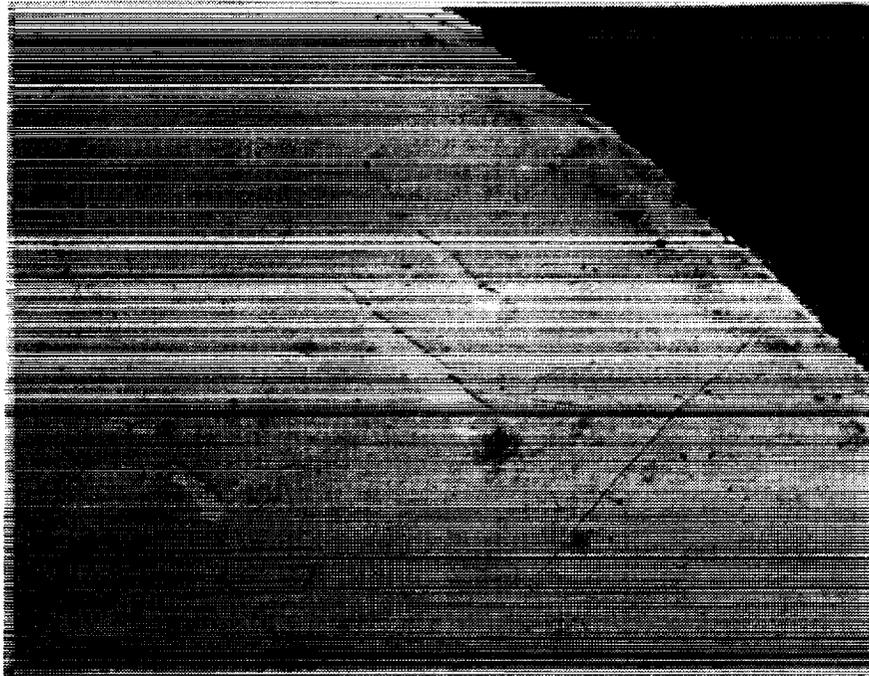
white paint were also made visible through the process of AO erosion (see figures 19 and 20). AO erosion left a very fragile surface layer on the white A276 paint that was occasionally damaged by incidental handling during deintegration and storage (see figures 17, 21, and 22). AO erosion of the black Z306 paint is also apparent, based on visibility of the red primer layer (see figure 23).

Figure 21. Chemglaze A276 white polyurethane paint on tray clamp C8-5, viewed at 16X magnification, showing the fragile nature of the eroded surface layer.

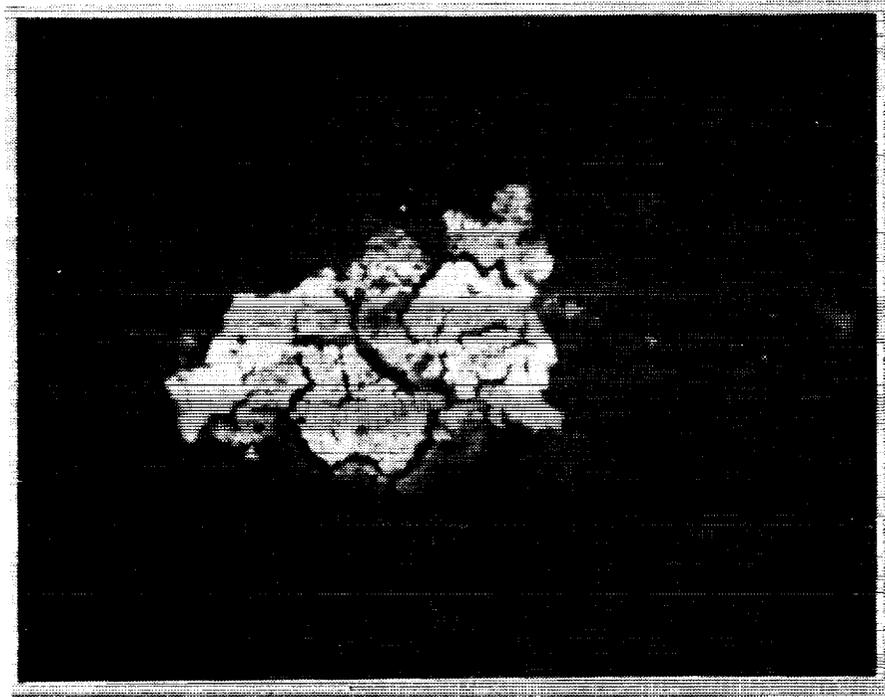
Figure 32. Chemglaze Z306 black polyurethane paint on Experiment M0003 composite panel, viewed at 200X magnification. The focus is on a silicate inclusion but atomic oxygen erosion to the red primer layer is visible. See Appendix C for color figure.

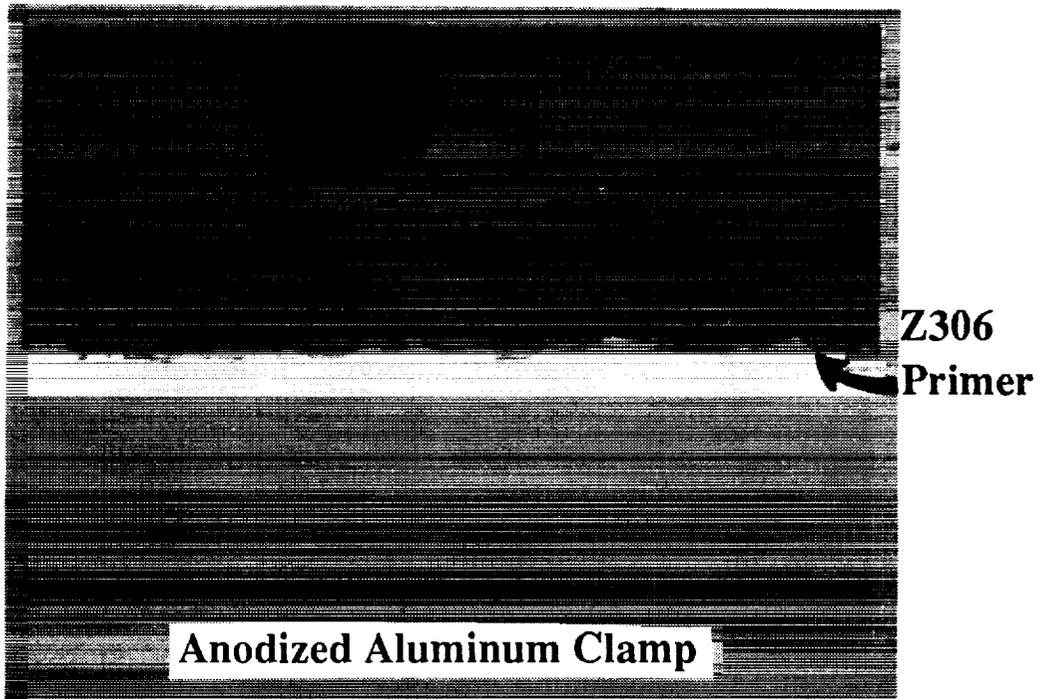
Figure 49. Cross-section of Chemglaze Z306 black polyurethane paint on tray clamp A6-2 at 500X magnification, full environmental exposure.

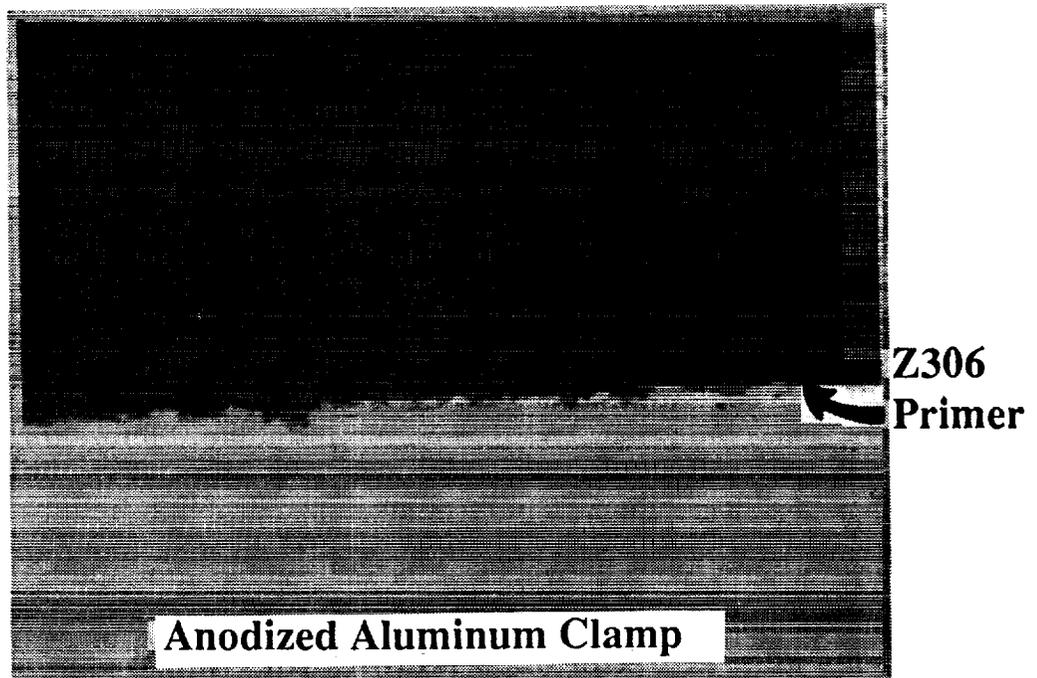
Figure 51. Cross-section of Chemglaze Z306 black polyurethane paint on tray clamp B4-7 at 500X magnification, full environmental exposure.

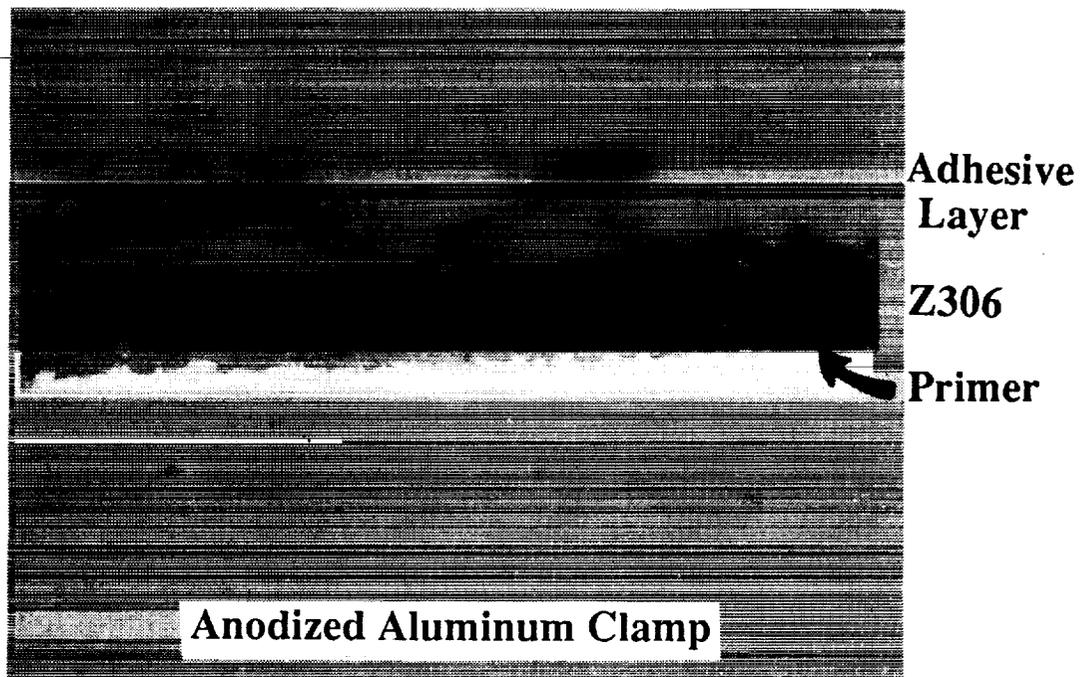
Figure 52. Cross-section of Chemglaze Z306 black polyurethane paint on tray clamp B7-2 at 500X magnification, protected from environmental exposure.

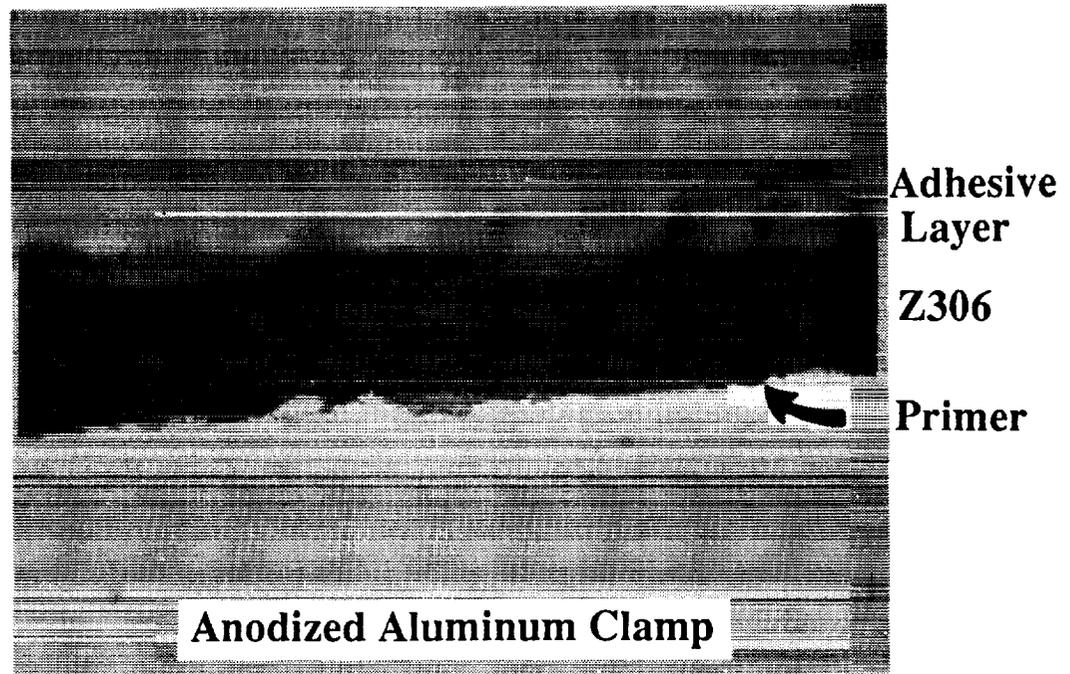
Figure 54. Cross-section of Chemglaze Z306 black polyurethane paint on tray clamp C8-5 at 500X magnification, protected from environmental exposure.

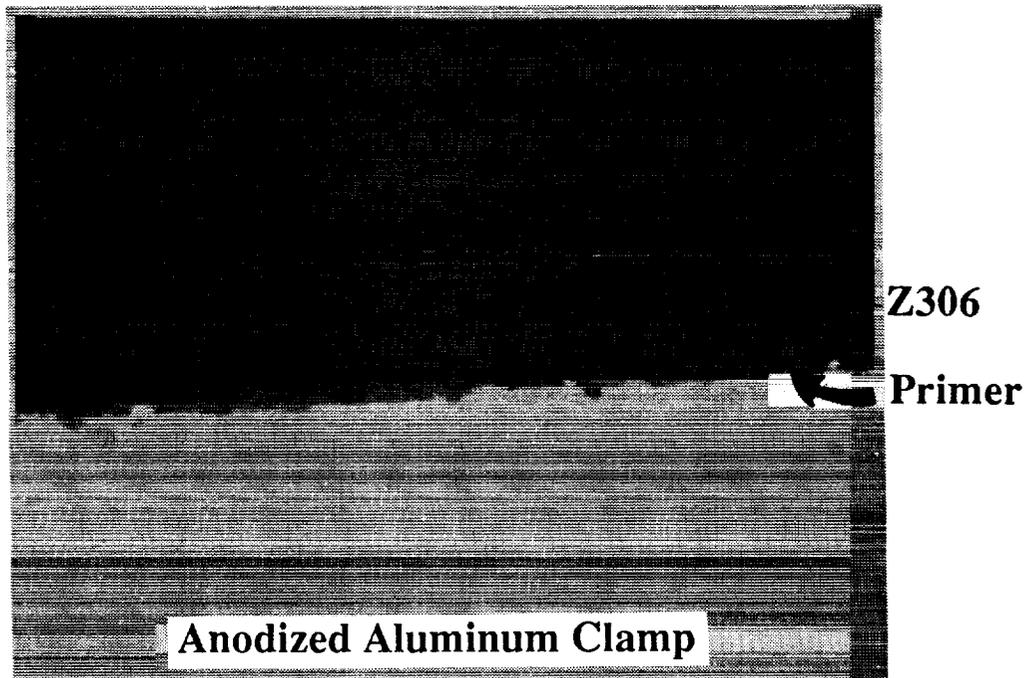
Figure 55. Cross-section of Chemglaze Z306 black polyurethane paint on tray clamp C8-5 at 500X magnification, full environmental exposure.

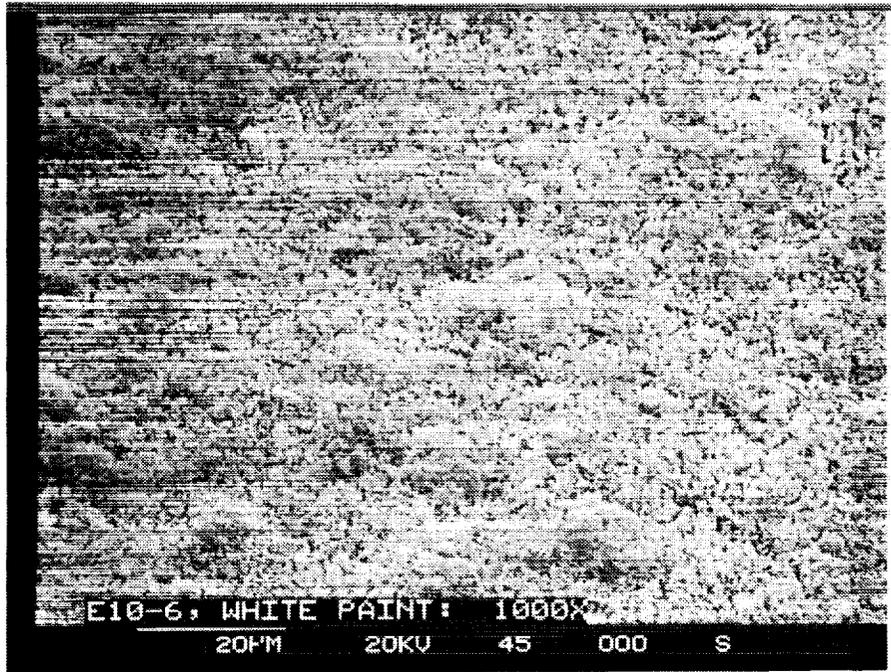
Figure 57. SEM of Chemglaze A276 white paint on tray clamp E10-6, 1000X magnification.

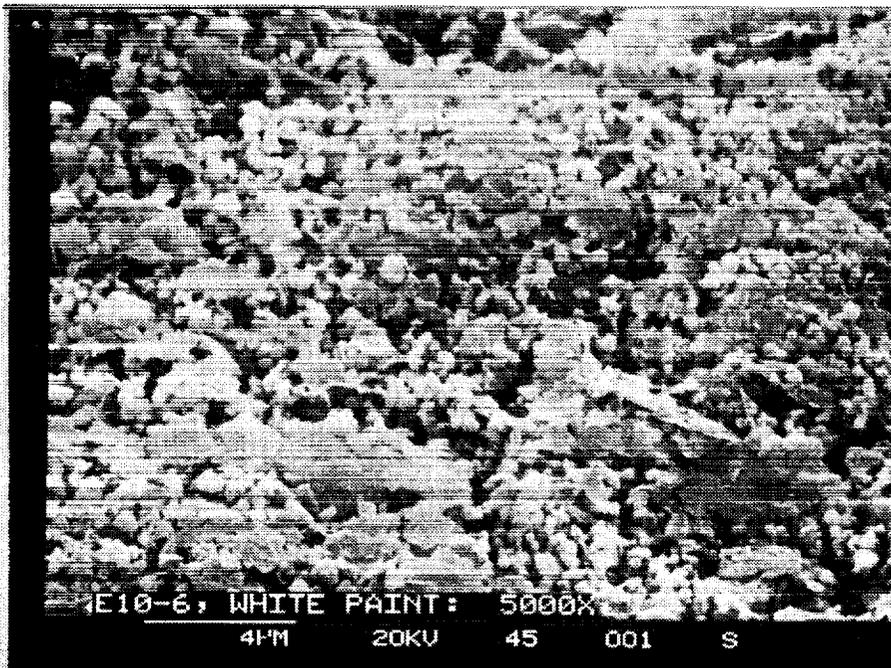
Figure 58. SEM of Chemglaze A276 white paint on tray clamp E10-6, 5000X magnification.

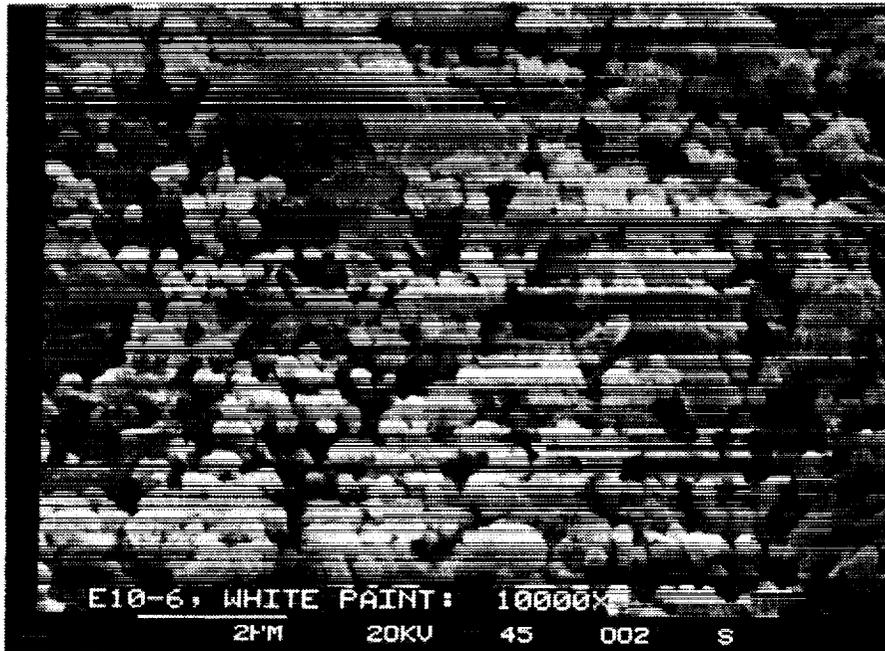
Figure 59. SEM of Chemglaze A276 white paint on tray clamp E10-6, 10,000X magnification.

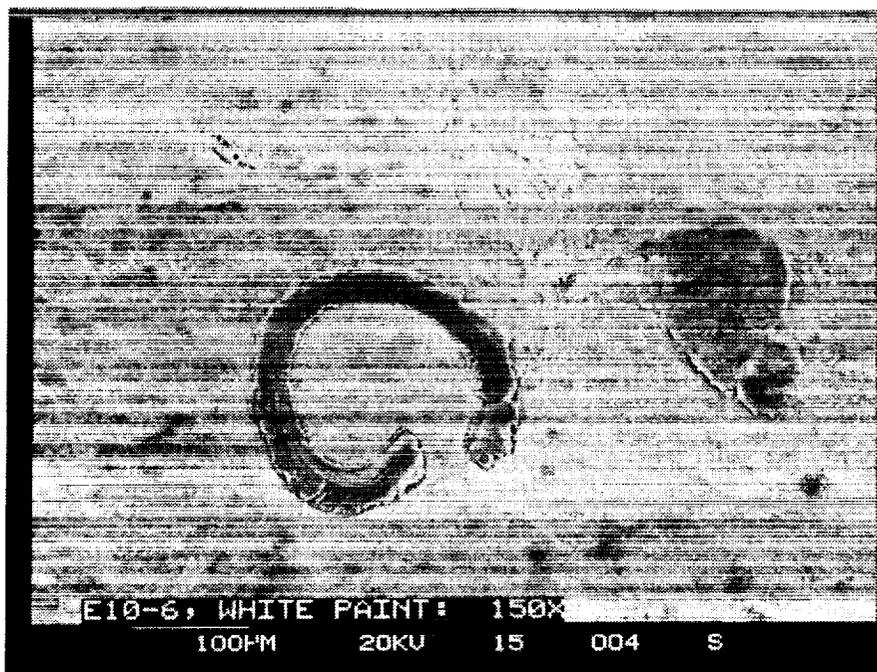
Figure 63. SEM of Chemglaze A276 white paint on tray clamp E10-6, showing two unusual and adjacent surface features at 150X magnification.

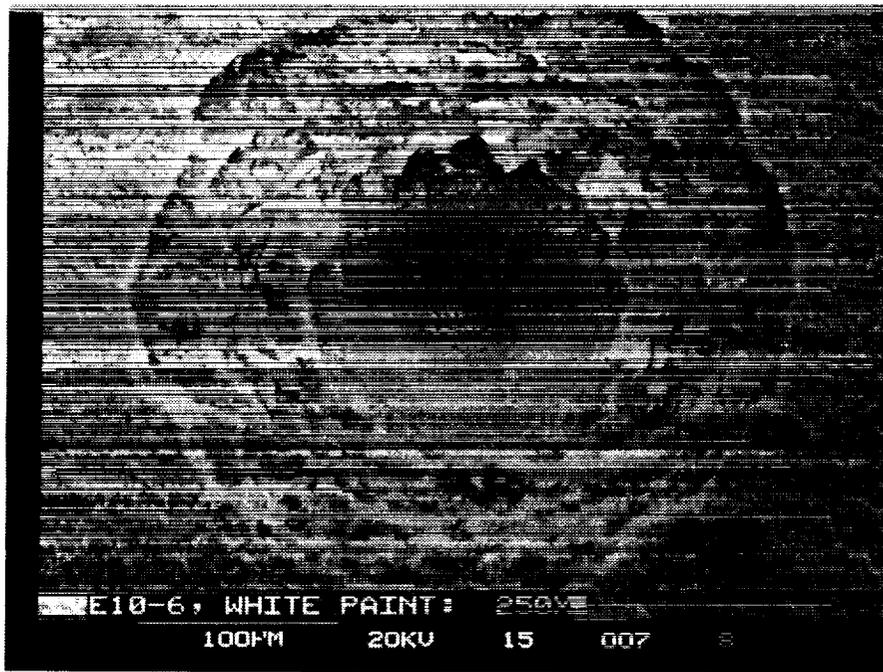
Figure 66. SEM of Chemglaze A276 white paint on tray clamp E10-6, focusing on a micrometeoroid or debris impact in the surface (250X magnification).

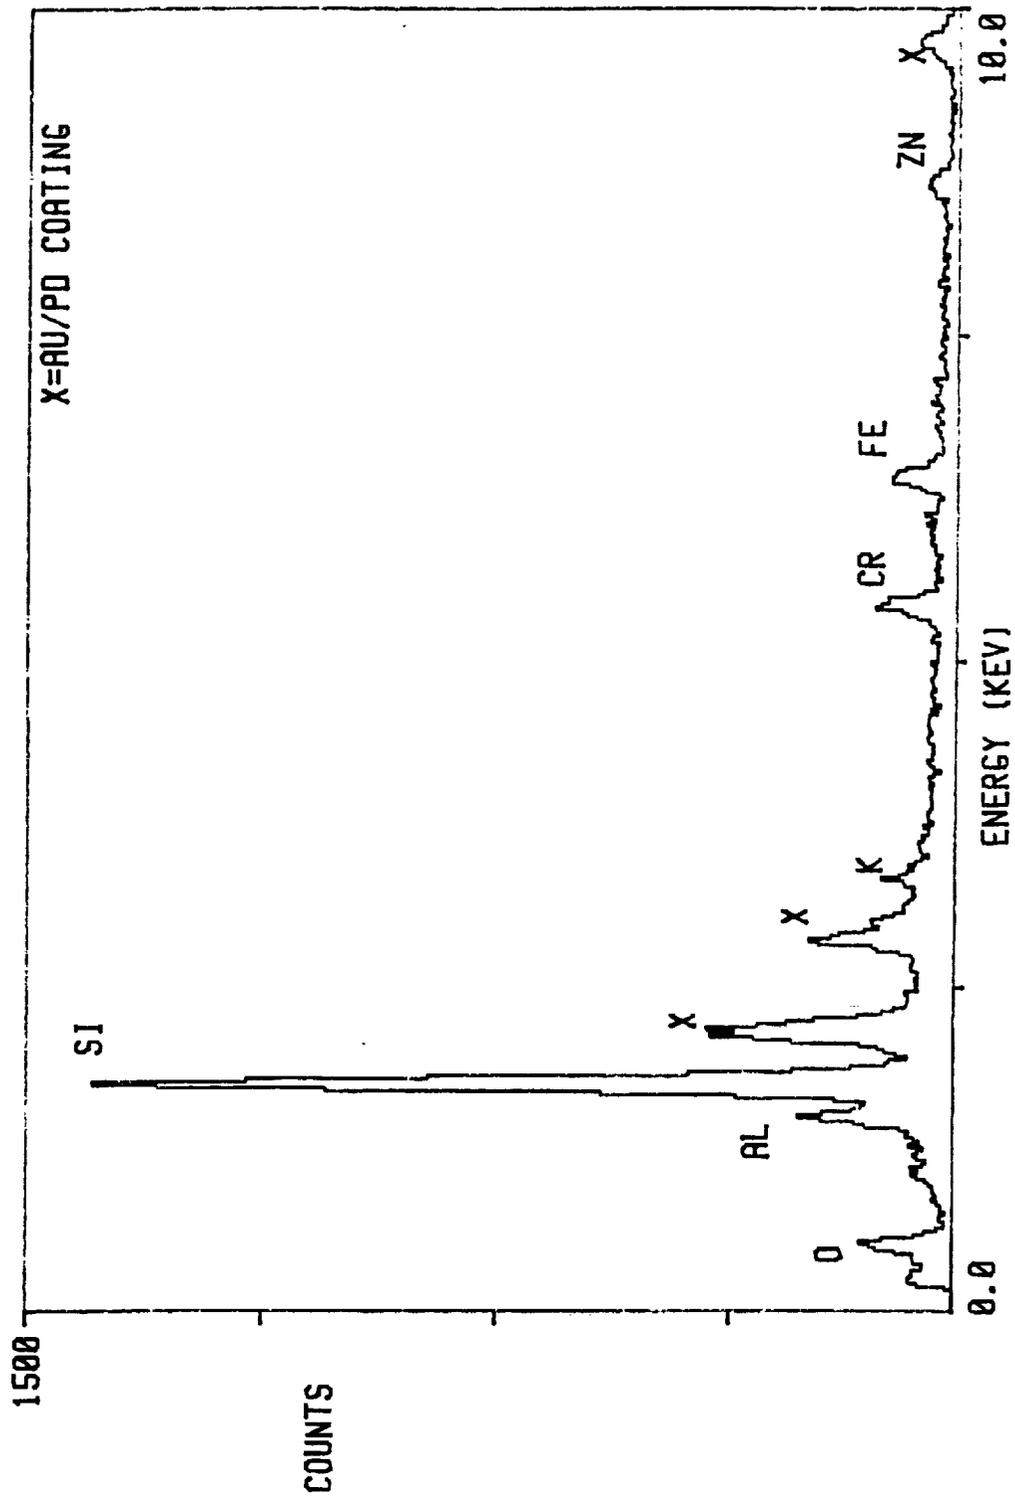
SEM images of the Z306 black paint surface from paint disks were of poor quality because of surface charging, despite multiple applications of vapor-deposited conductive metal. However, surface chemical analysis was obtainable by electron microprobe, as shown in figure 68. The presence of silicon was strongly indicated, caused by the silica used in the paint pigment package. The presence of chromium, iron, and zinc was

Figure 68. Electron microprobe chemical analysis of Chemglaze Z306 black paint on tray clamp E10-6.

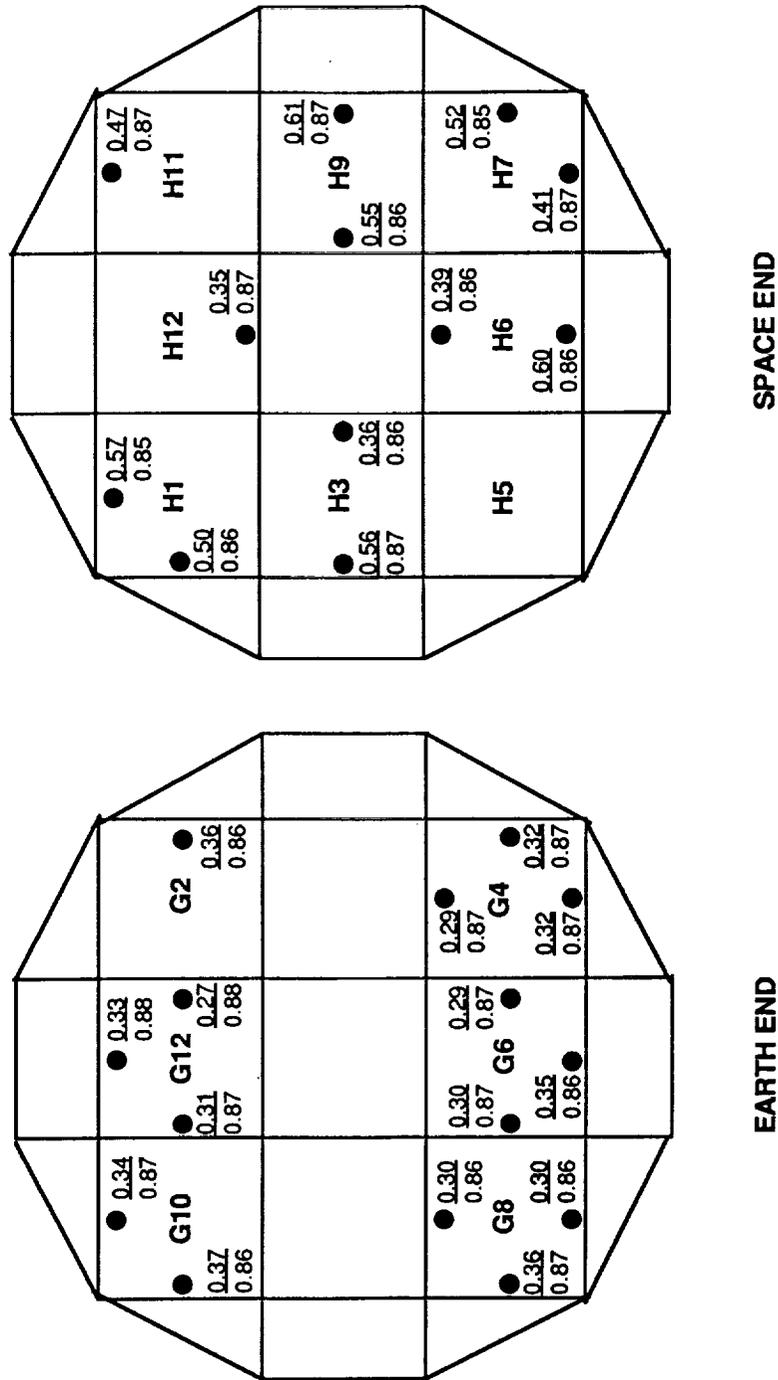
Measurements made for white paint disks from the Earth and space ends of LDEF are shown in figure 79. Emittance measurements indicated no significant differences between disks on the Earth or space ends. The absorptance readings were generally greater for the peripheral areas at either end. Further discussion of the Earth and space end absorptance measurements will be made later with the correlations to environmental exposure.

Figure 79. Solar absorptance / thermal emittance ratio for Chemglaze A276 white polyurethane paint on LDEF Earth and space end tray clamps.

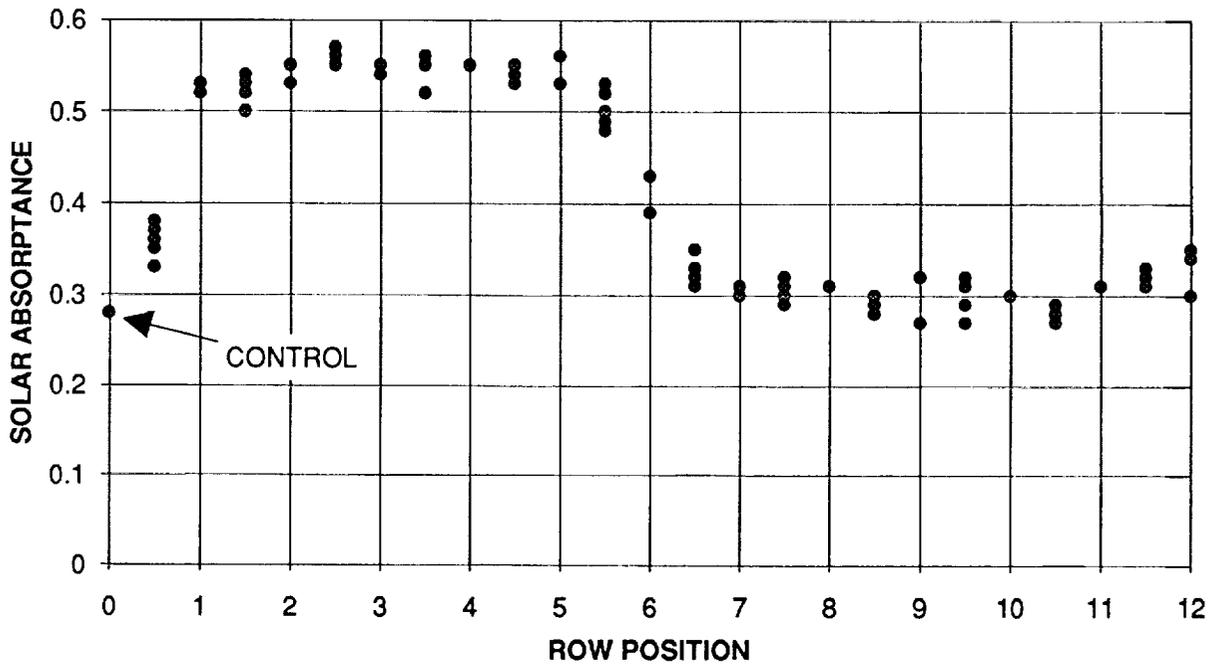
Absorptance measurements as a function of row position are shown in figure 81. Multiple specimens measured along a particular row indicated limited variability in absorptance. This variability was random, not indicating any trends in absorptance along the length of the spacecraft. The data do not quite form a symmetric distribution due to the offset in LDEF yaw (ref. 5). Control specimen absorptance was comparable to that from specimens on rows 9 and 10.

Figure 81. Solar absorbance for Chemglaze A276 white paint versus row position.

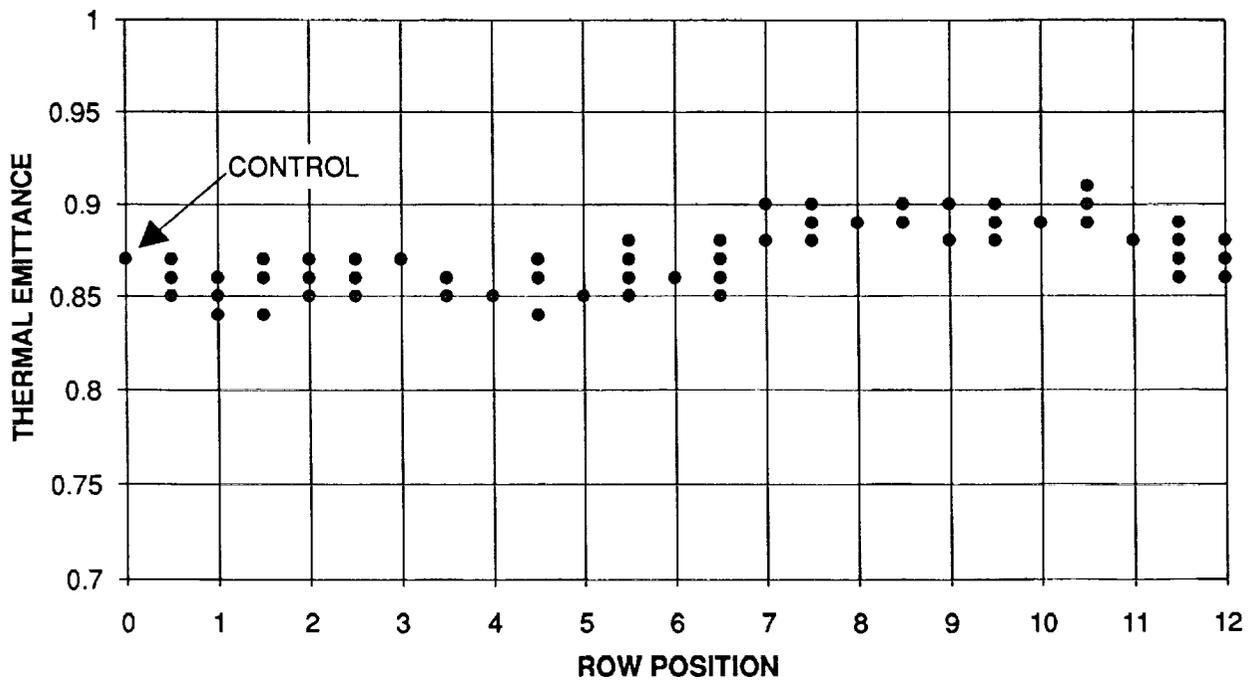
Emittance measurements as a function of row position are shown in figure 82. Control specimen emittance was comparable to measurements made for specimens on trailing edge surfaces, rows 1 through 6.

Figure 82. Thermal emittance for Chemglaze A276 white paint versus row position.

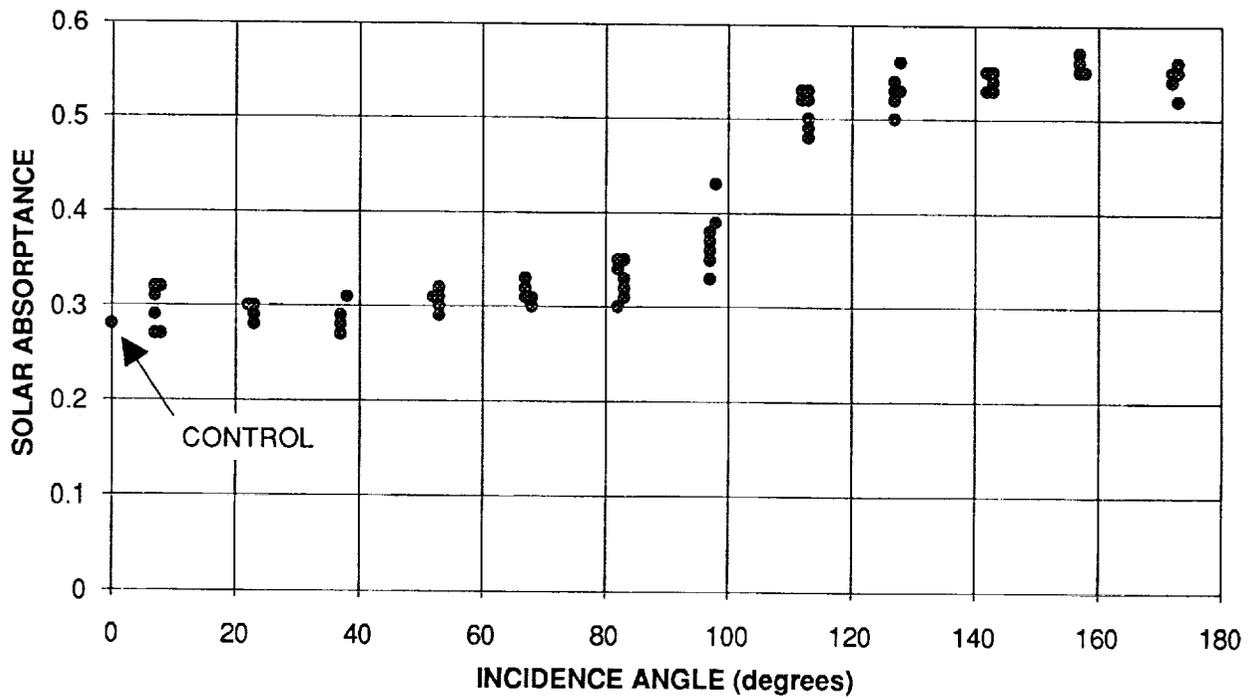
The absorptance and emittance measurements were plotted versus angle of AO incidence in figures 83 and 84. The incidence angles were based on an assumed eight degree offset in yaw angle (ref. 5). Figure 83 shows that the erosion effect of atomic oxygen yielded low absorptance levels for the A276 paint for incidence angles up to 80 degrees, with an apparent atomic oxygen effect discernible to an incidence angle of 100 degrees. It is actually fortunate for the present analysis that LDEF had a yaw offset. Due to the extremely steep solar absorptance change in the AO fluence transition region, the yaw offset provided two separate incidence angle environments in the transition area. Statistical analysis conducted on the emittance measurements graphed in figure 84 indicated a marginal but significant increase in emittance for leading edge white paint specimens (incidence angle less than 70°,  $\epsilon = 0.89 \pm 0.01$ ) as compared to the control ( $\epsilon = 0.87$ ) and to trailing edge specimens (incidence angle greater than 100°,  $\epsilon = 0.86 \pm 0.01$ ). The increase in emittance is consistent with the roughening of leading edge surfaces observed by microscopy, caused by atomic oxygen erosion of the paint resin.

Figure 83. Solar absorbance for Chemglaze A276 white paint versus atomic oxygen incidence angle.

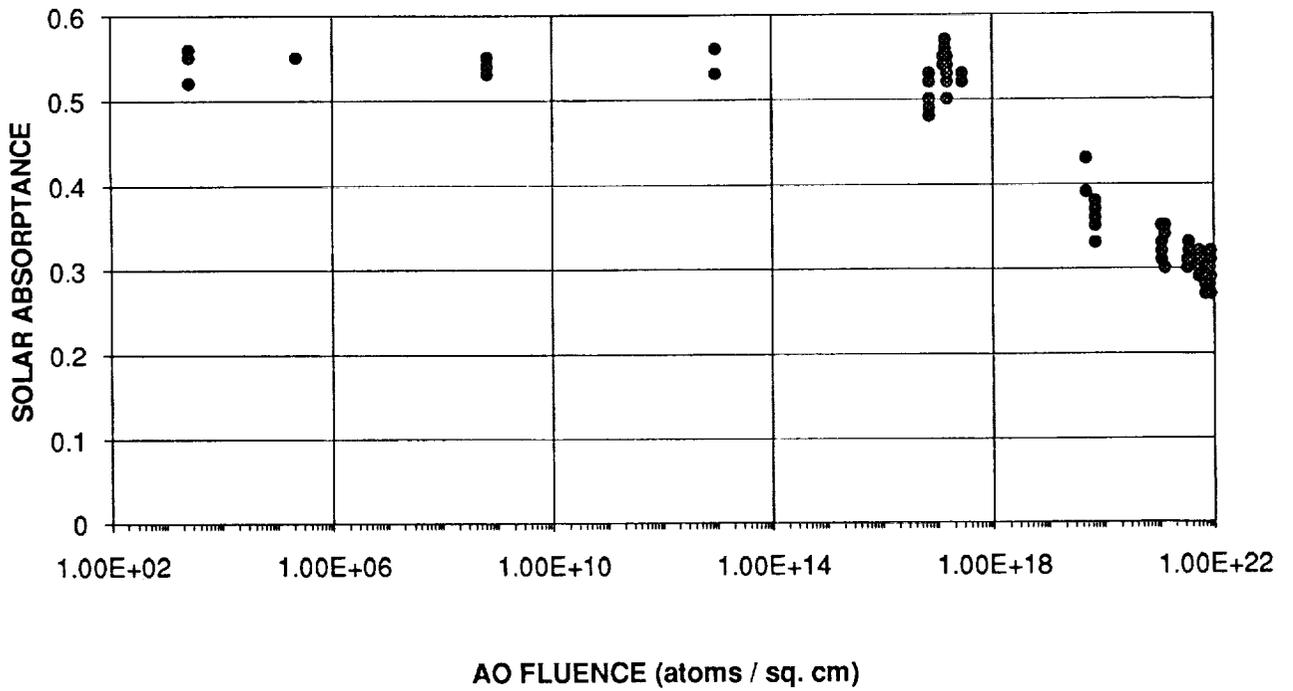
In an attempt to characterize the environmentally induced changes observed for A276 paint, figure 85 represents solar absorptance measurements as a function of atomic oxygen fluence. The atomic oxygen fluence levels used in figure 85 are predictions based on the LDEF AO fluence model developed by Boeing (ref. 1). Atomic oxygen fluence is represented logarithmically. Absorptance data from Earth and space end disks are not included in figure 85, due to the scatter in those data which will be discussed later. From figure 85, a fluence level of  $10^{21}$  oxygen atoms per  $\text{cm}^2$  was necessary to cause sufficient resin erosion in the A276 white thermal control paint to maintain coating optical performance, removing the darkened resin which degraded the coating's absorptance.

Figure 85. Solar absorbance for Chemglaze A276 white polyurethane paint versus atomic oxygen fluence.

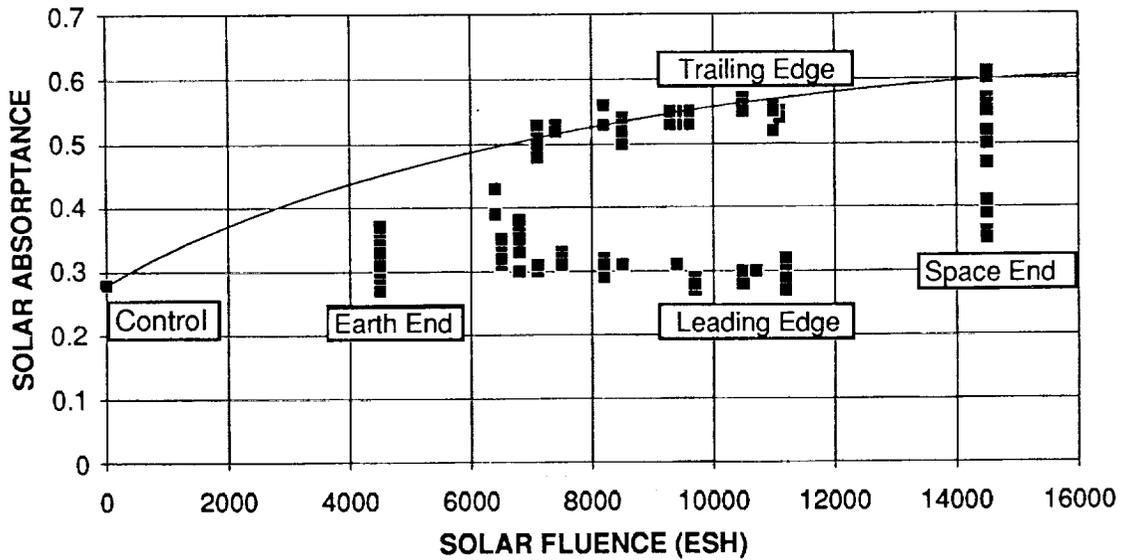
However, it must be recognized that coupled with the atomic oxygen effect was the effect of UV radiation. Figure 86 shows the absorptance of all A276 white paint disks measured, including Earth and space end disks, as a function of predicted solar fluence in equivalent sun hours (ref. 2). Also included in figure 86 are data from LDEF Experiment S0069 for comparison (ref. 6).

Figure 86 suggests a solar absorptance increase for A276 that accompanied increasing UV exposure in the absence of atomic oxygen. Part of the evidence for this trend is from the data provided by experiment S0069, where in-situ absorptance measurements were made and recorded as a function of mission time. Experiment S0069 measured an increase in the absorptance of A276 occurring in the early, low atomic oxygen flux portion of the LDEF mission. Taken as a whole, the data in figure 86 suggest that all of the A276 paint disks were darkening according to this trend in the initial years of the LDEF mission. This was when LDEF was still in a relatively high orbit. But as the orbital altitude began to decay, the atomic oxygen flux began to increase rapidly. The AO flux model has predicted that about 54% of the atomic oxygen fluence on LDEF occurred in the last six months of the mission (ref. 1). It was during this latter phase of the LDEF mission that atomic oxygen erosion removed UV damaged paint resin where the total fluence was sufficient, and brought A276 absorptance readings back to nominal levels on leading edge specimens. It does not appear that the trailing edge specimens have yet reached an end-of-life condition versus UV exposure, although the apparent rate of absorptance degradation with UV exposure has decreased significantly for the highest level UV exposed specimens. It does, however, appear that the leading edge specimens have reached an end-of-life condition versus AO exposure.

Figure 86. Solar absorbance for Chemglaze A276 white polyurethane paint versus ultraviolet radiation exposure.

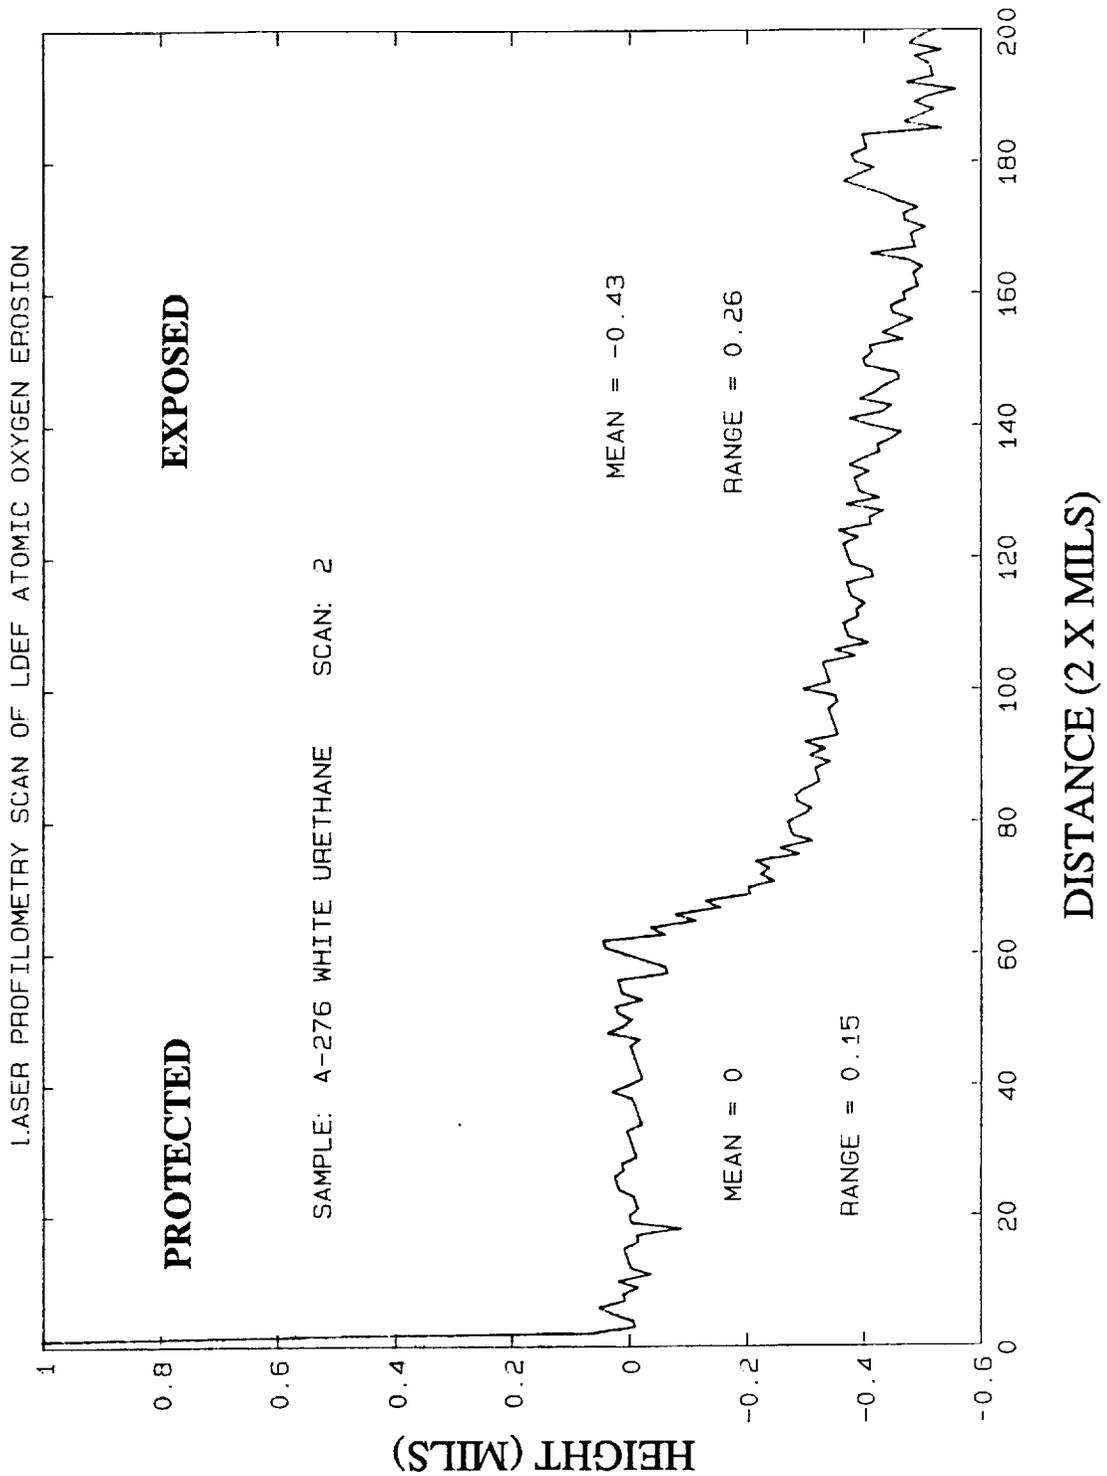
Additional measurements were made in an attempt to clarify the extent of AO attack on the thermal control coatings, where attempts such as cross-sectioning had failed. One such measurement involved the A276 paint on the composite panel from experiment M0003. The composite panel had areas totally protected from atomic oxygen attack, where washers had been used for attachment of the panel to support structure. The measurement involved determining how deeply atomic oxygen was able to penetrate into the layer of remaining pigment particles by measuring how deep the exposed paint was damaged from a physical integrity perspective. Specimens were cut from around the protected attachment areas, and the loose pigment on AO eroded surfaces was totally removed by repeated rag wiping until no more pigment loss was observed. Surface profiles from the specimens were then measured using laser profilometry. Height profiles from these measurements are shown in figures 87 - 92. Figure 87 exhibits an anomalous region at the protected to exposed interface, apparently the result of a cut formed by the sharp edge of the washer when it spun on the surface during fastener removal. Maximum coating loss measurements ranged from 0.00025 inch in figure 92 to 0.00050 inch in figure 90. Average AO erosion damage depth was determined to be 0.00038 inch or 9.6  $\mu\text{m}$ .

Figure 90. Laser profilometry scan of Chemglaze A276 white polyurethane paint, moving from a protected area to an AO exposed surface, from which all loose paint pigment had been removed. Specimen was taken from the A276 paint corner of the Experiment M0003 composite panel (see figure 10). Scan taken 90° from figure 89 scan.

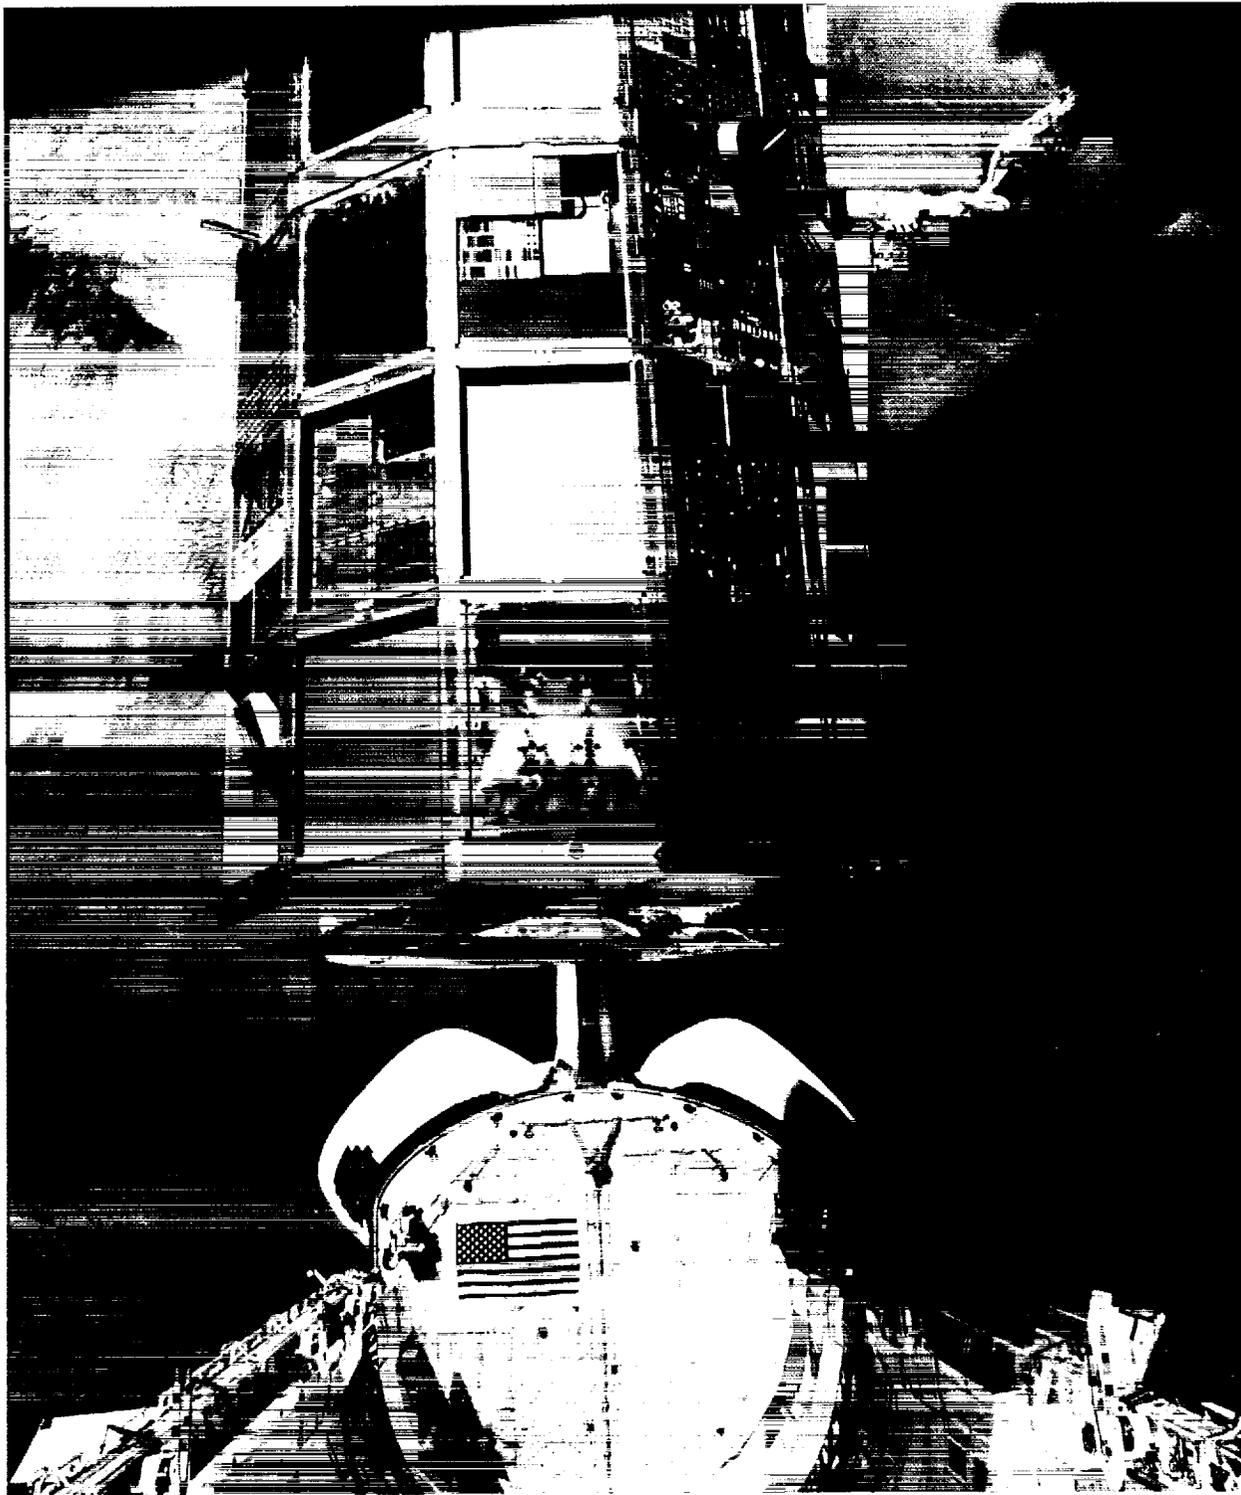
Figure C1. LDEF retrieved as viewed from the Shuttle Columbia on January 12, 1990. NASA Langley Research Center Photo No. 90-10472. Color version of figure 1, page 13.
